Technical Preservation Services
Preservation Assistance Division
National Park Service
U.S. Department of the Interior
Washington, D.C.

Interpreting the Secretary of the Interior's Standards for Rehabilitation

Volume III

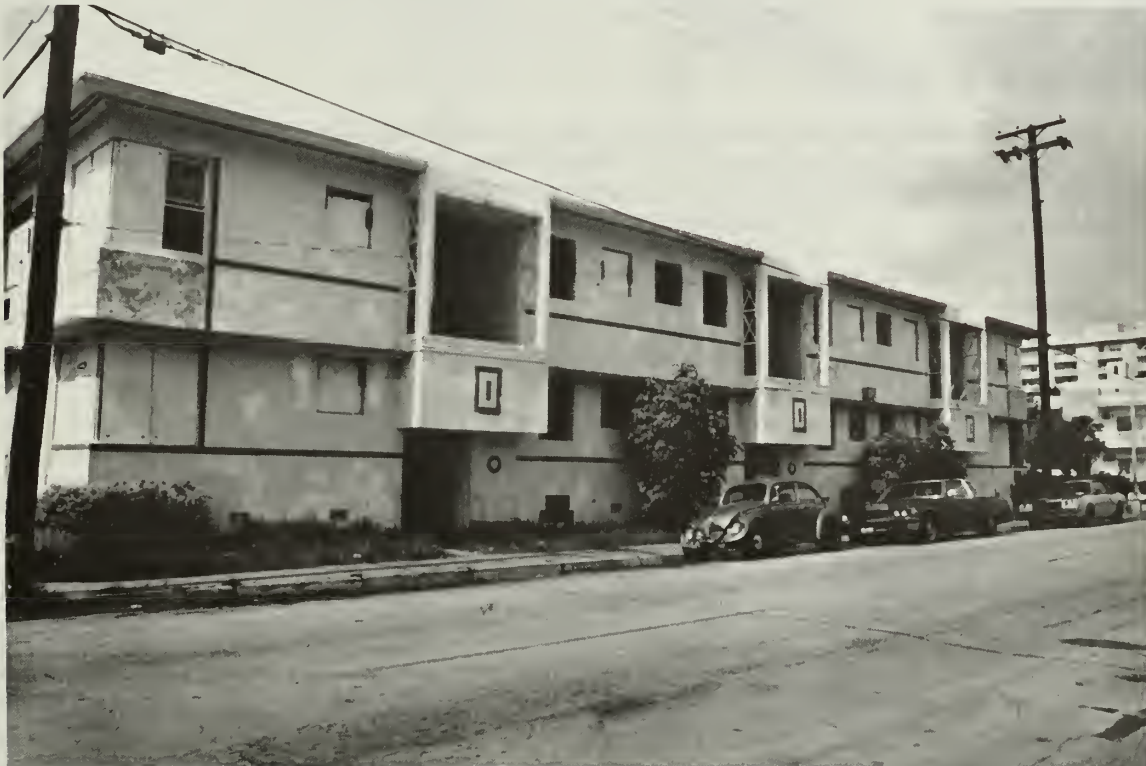
2. The street elevation of the building where patch repair work has already begun shows the decorative panels of local stone under the second story windows at either end of the building.

As part of the rehabilitation, the exterior stucco, which had been repaired and patched as necessary, was painted as the owner himself stated, in a "fanciful and sportive manner." Prior to rehabilitation, the building had been painted beige with a few of its decorative features highlighted in a darker brown. After rehabilitation, the wall surfaces of this building had been transformed by the application of numerous colors and decorative painted and patterned surfaces (see illus. 3-5). Wall surfaces were painted in alternating horizontal bands of aqua, yellow and pink, and projecting horizontal overhangs and the raised geometric panels were boldly outlined in black. Most notable was the use of paint to create contemporary stylized patterning, exaggerated illusionistic stone textures on door surrounds and above door panels, and a "cracked-tile" pattern above second-story stairwells and on planters surrounding the base of the building.

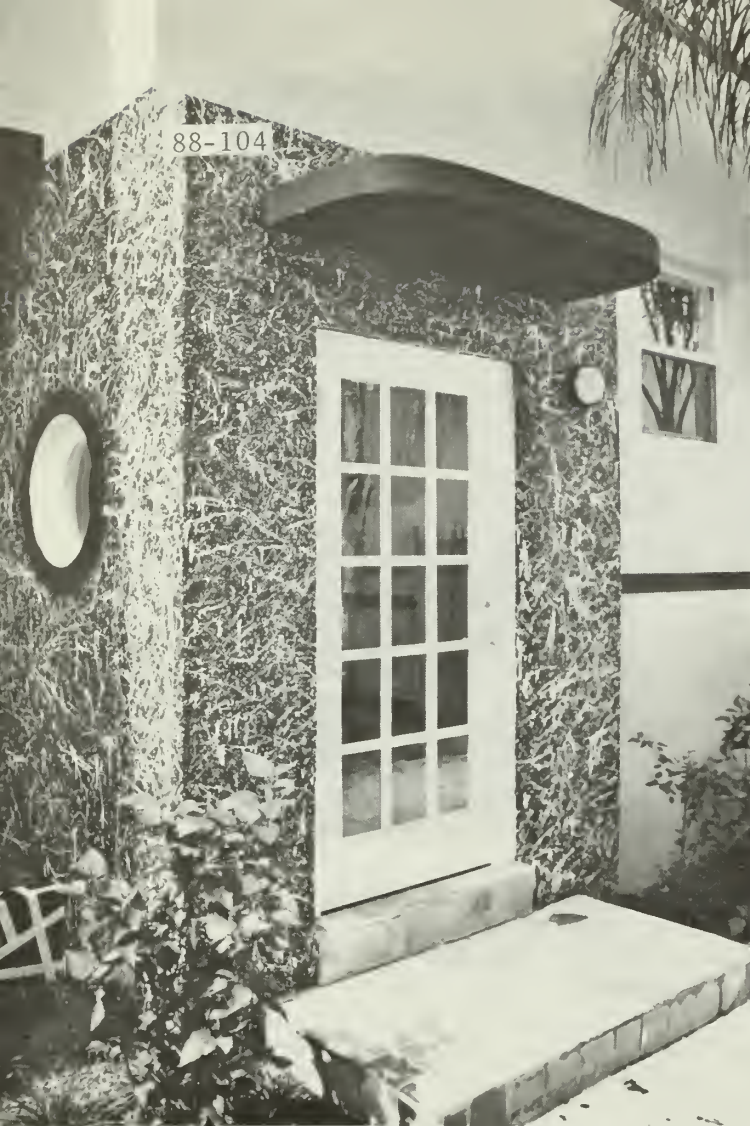
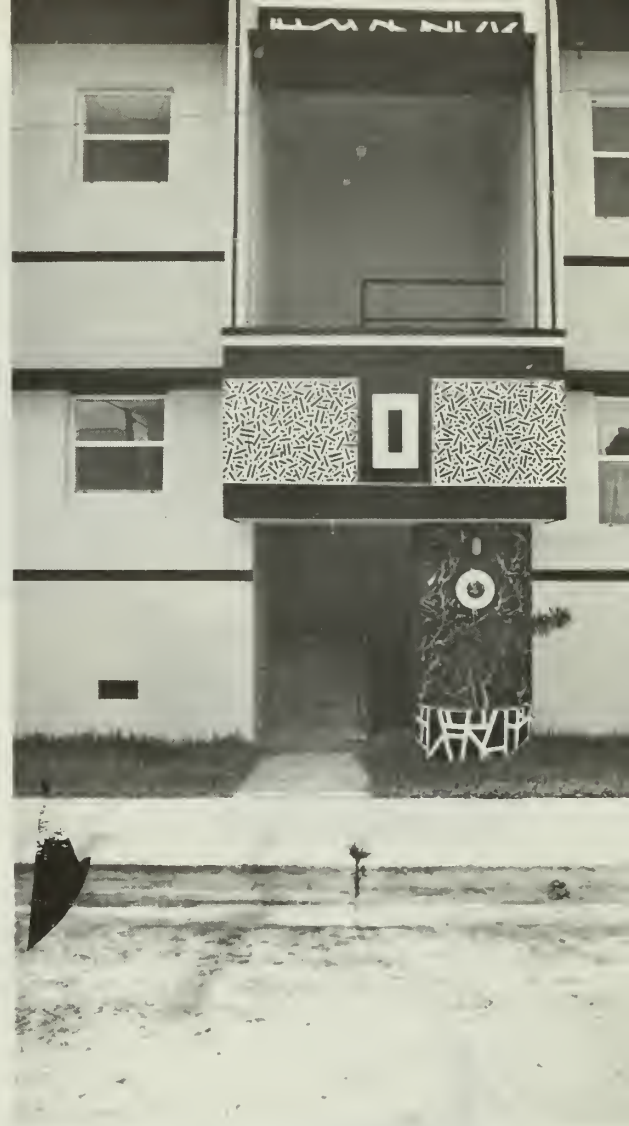
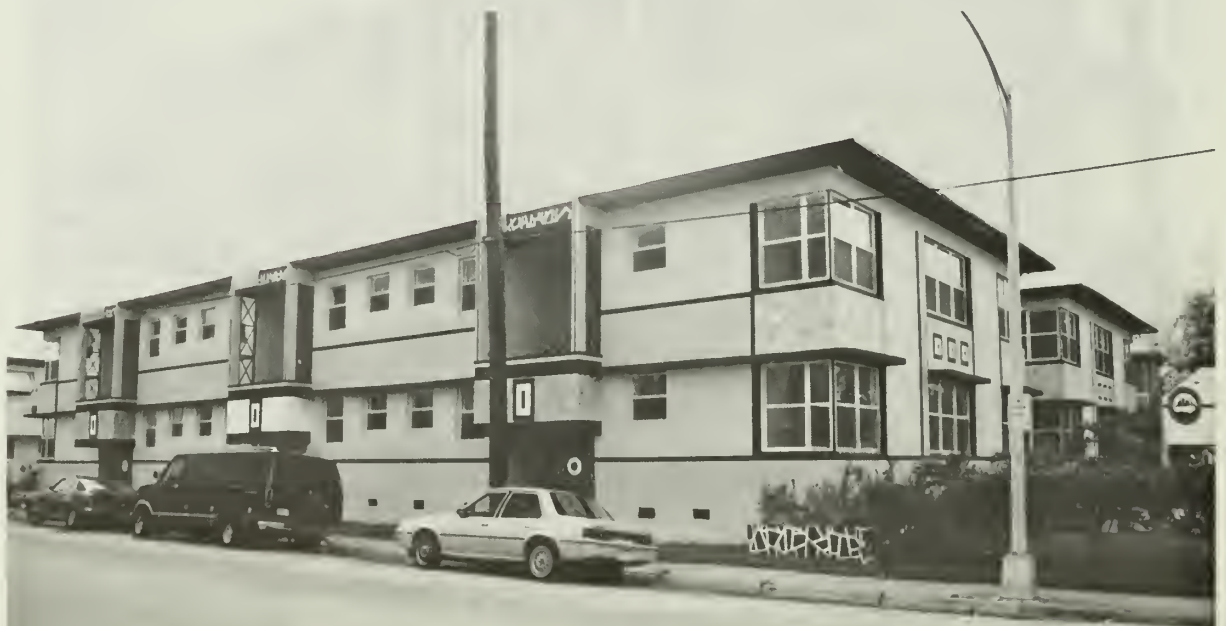
3-5. After rehabilitation the character of the building has been greatly changed by the application of a variety of decorative painted finishes, in particular the "faux" stone surfaces around doors, the contemporary patterned design used above doors and on balconies, and the "cracked tile" pattern on the planters that surround the building.

Consequently, as no evidence was presented to indicate that this type of exterior decorative painting had ever existed on this particular building, nor indeed on any building located in the historic district, it was determined that the decorative painted abstract patterns and faux finishes applied during the rehabilitation were inconsistent with the historic character of the building, and the historic district. The plain, unpatterned aqua, yellow, and pink colors on the walls were not considered objectionable, or in violation of the Standards, although it is most unlikely that they would have existed historically either in such a combination, or in such intense colors.

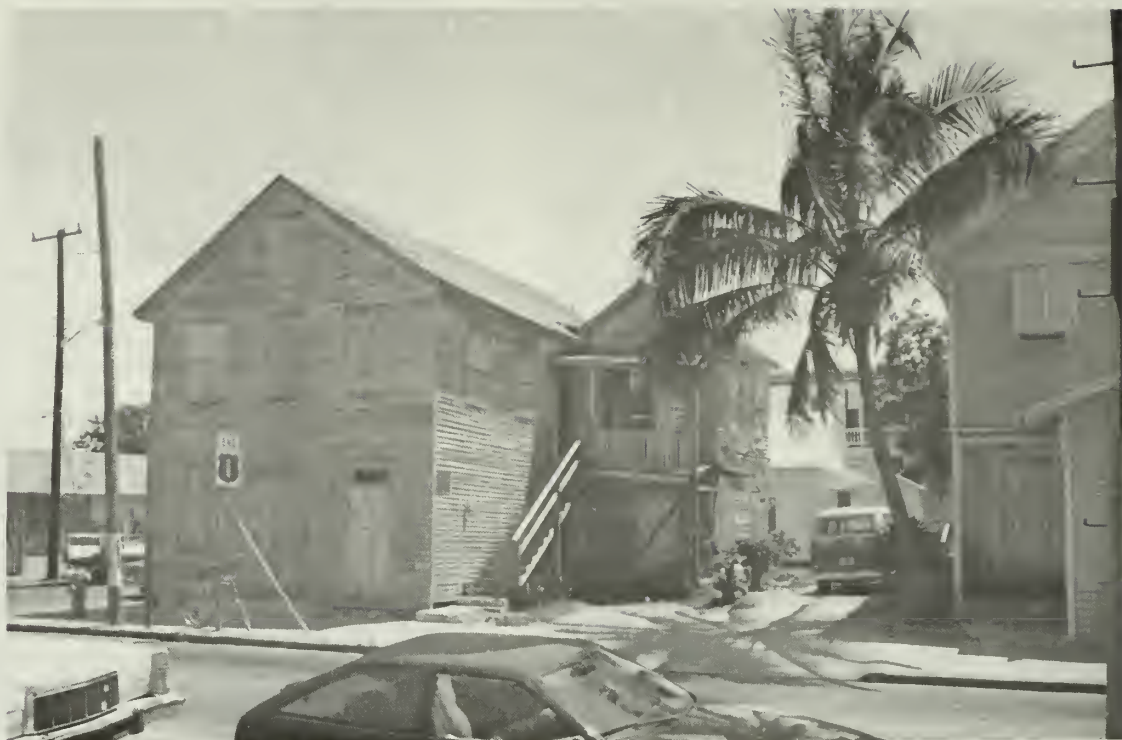
1. This view shows the exterior staircase in place before rehabilitation. Although this staircase was a replacement of the original, the feature was significant because it had remained in the same location and because it announced a separate use and function for the second floor of the ell.

The existing staircase was constructed within the last fifteen years; no remnant of the original feature had survived to guide replication and photographic documentation was unavailable. In view of the Standard's cautions against reproductions which are purely conjectural, the owner maintained that any attempt to reconstruct a staircase would misrepresent the original type. Because the narrow width and deteriorated condition of the staircase made it undesirable to retain, the decision was made to remove the staircase entirely with no attempt at reconstruction.

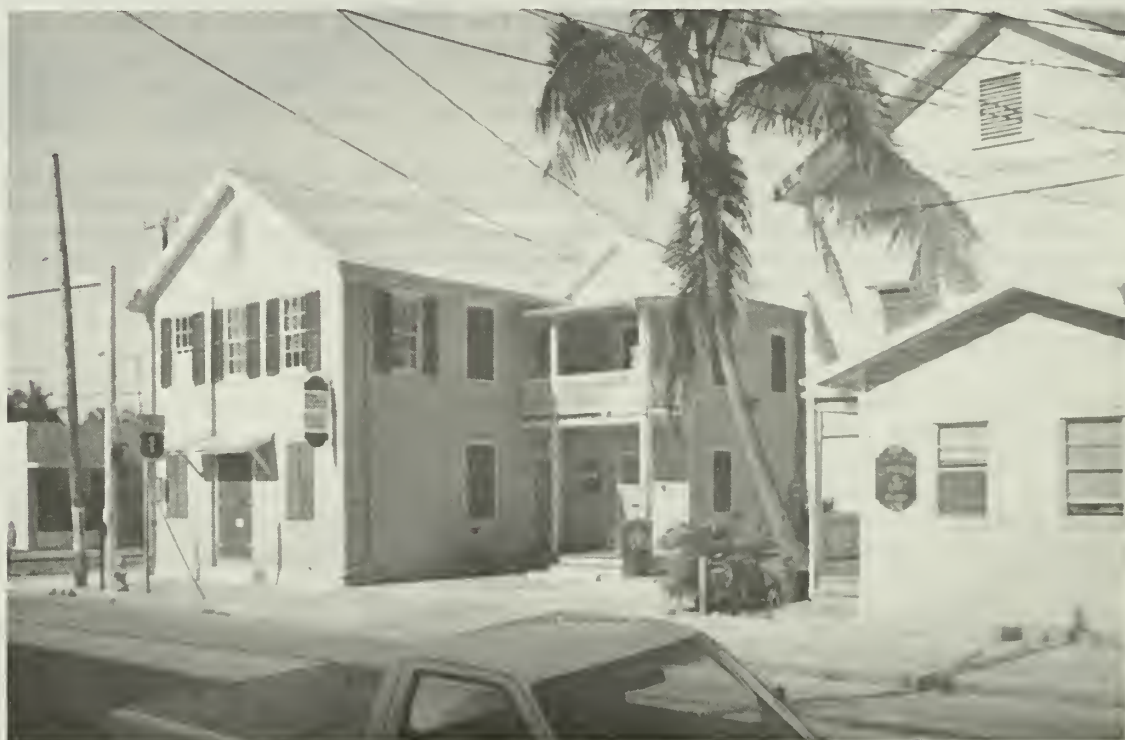
2. With the removal of the staircase there is no longer an indication of the second floor's independence from the first. The two floors of the ell addition appear to be functionally integrated.

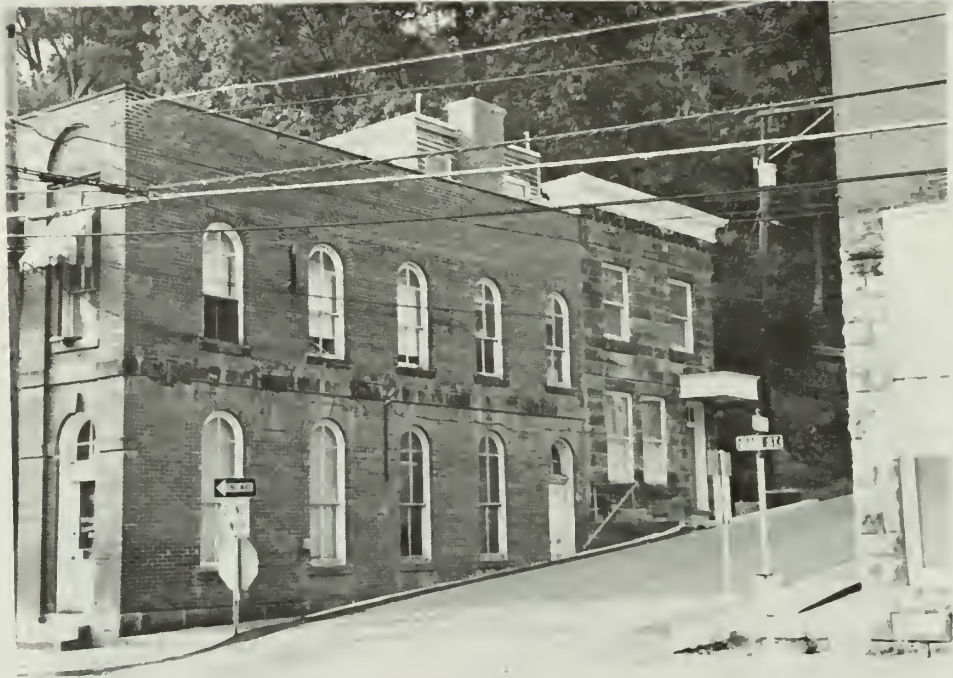
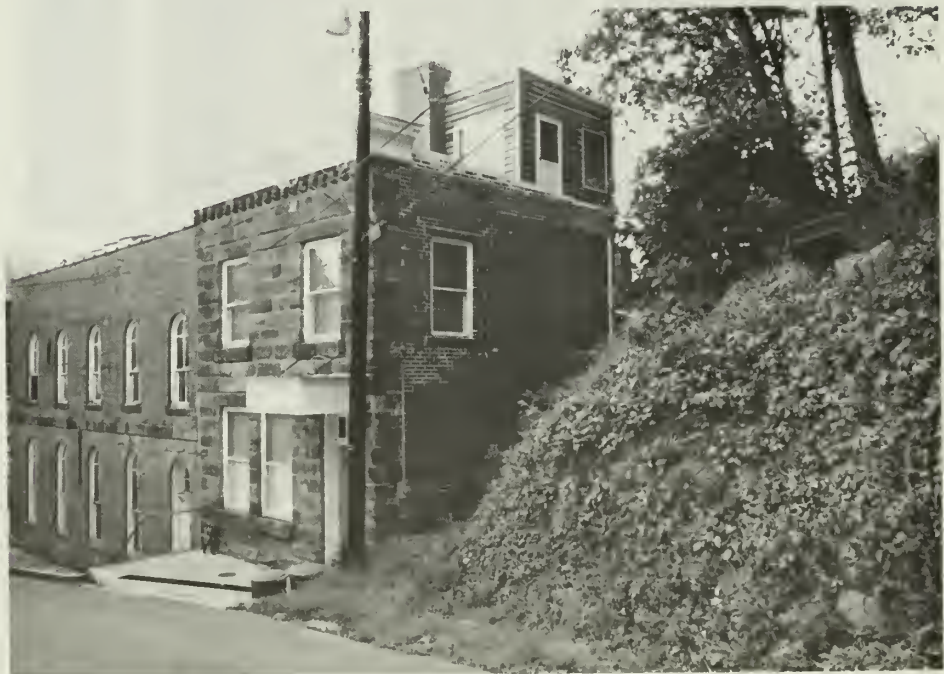
2-3. After rehabilitation, the new rooftop addition is highly visible within the historic district, both from below the building at the main intersection at the foot of the hill, and from above the building higher on the hillside.

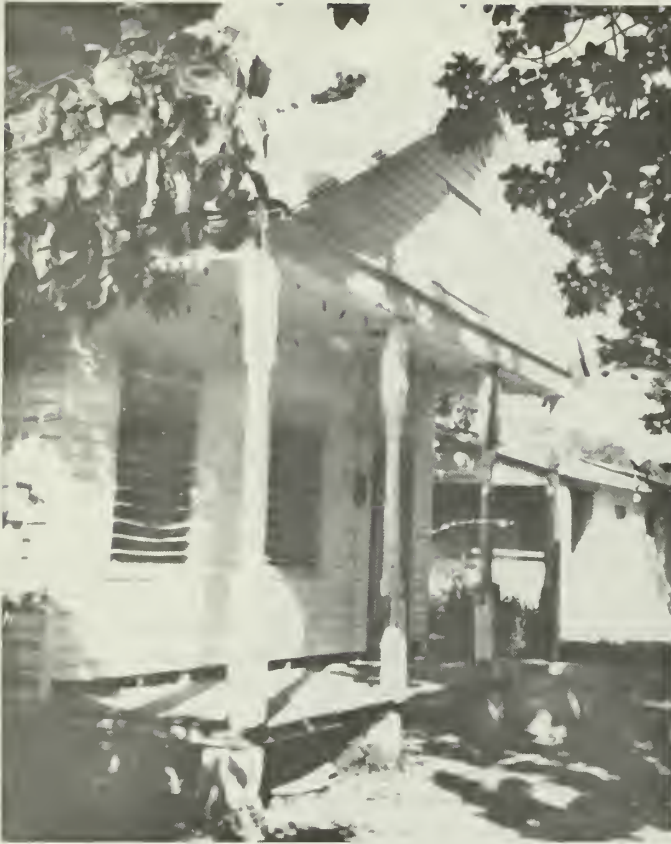
1. Simple turned posts and plain windows were the only expressive details of the vernacular frame building.

Application: In a historic district of vernacular wood frame dwellings, the main facade of a small, single story, simply detailed 1900 building was elaborated with details suggesting the Greek Revival style (see illus 1.) Triangular pediments were added to the window heads, and simple turned posts were replaced with square, Doric posts (see illus 2.) The resultant changes undermined the vernacular simplicity of the Victorian structure. Although buildings within the historic district built about the same time were fitted with Greek Revival details, they were without exception larger, more imposing structures. No other authentic examples of modest, similarly adorned structures could be found. However, even if such examples could be cited, the evidence would not prove that this building ever had these particular features.

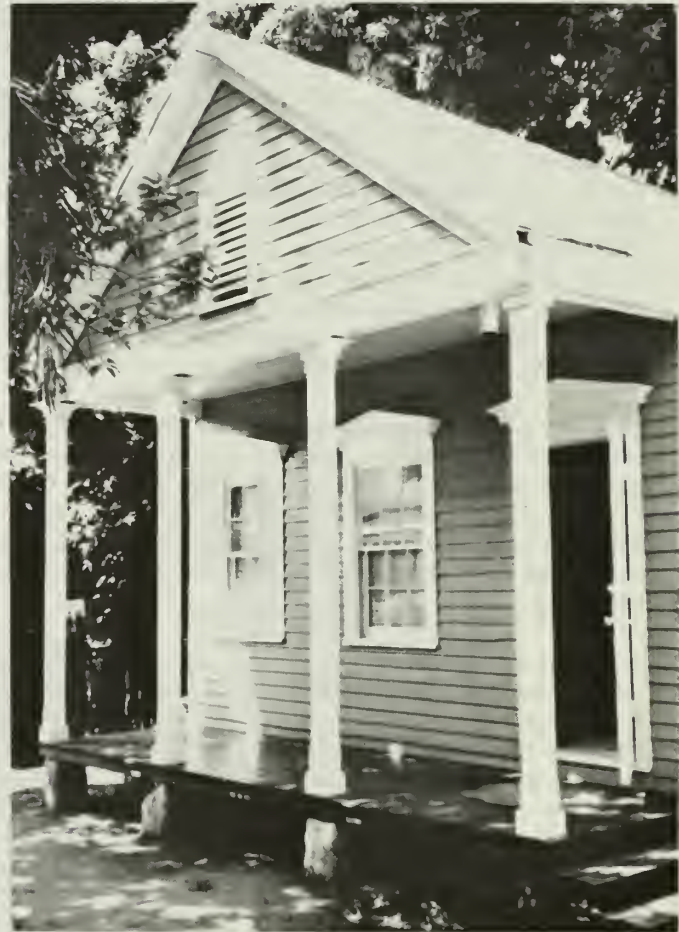
2. The dramatic shift in appearance from a vernacular structure to a higher style building is achieved with Greek Revival posts and triangular window pediments. The building was not originally fitted with these details, nor is there any occurrence of these features on a facade of this size within the district.

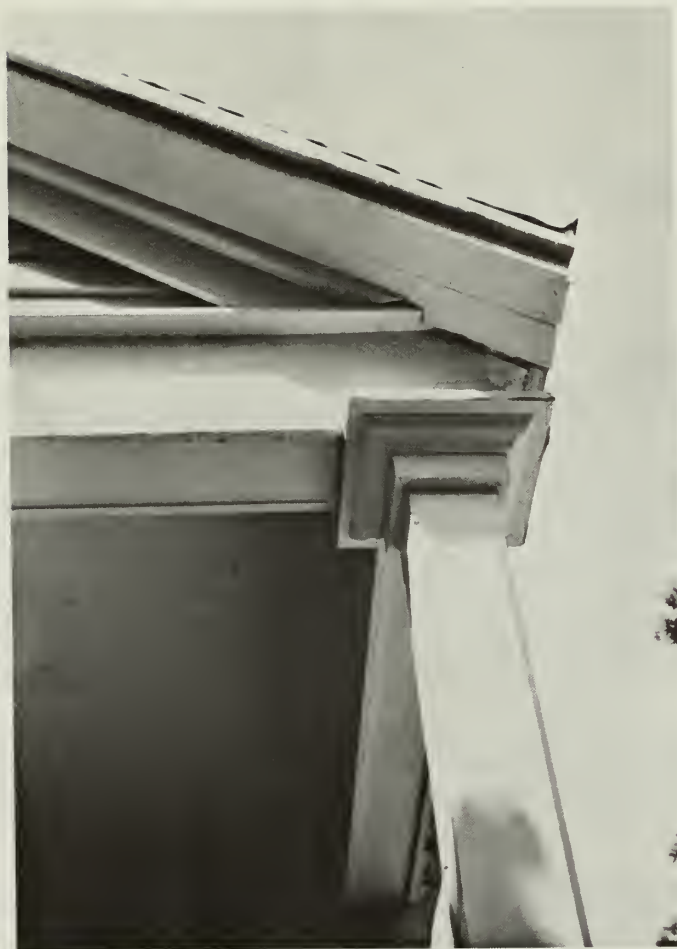
3. Not only have the added features created a non-historic appearance for the facade, but the size of the new capitals does not conform to the narrower dimensions of the overlying gable and causes an awkward overlap of the cornice. Compare with the photograph taken before rehabilitation which reveals the compatible proportions of the turned posts and the gable it supports.

The use of unprecedented details on this small facade is also historically and visually improper because the proportions of the new features create awkward junctures with the existing cornice. For example, the capitals of the posts are improperly scaled and project beyond the gable soffit (see illus 3.) The building's new presentation as a Greek temple is also unsuccessful due to the lack of entablature and requisite Classical cornices and moldings that would normally be found in the overlying gable of a true Greek Revival building.

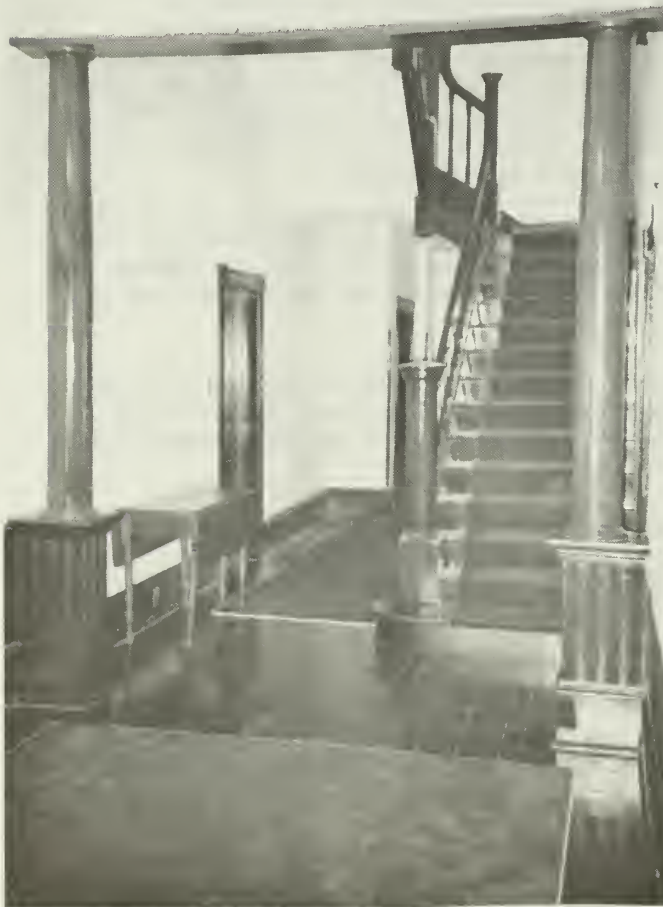
1. The only primary space on the first floor left unaffected after rehabilitation was the central hall, shown here with its original ceiling height and column divider.

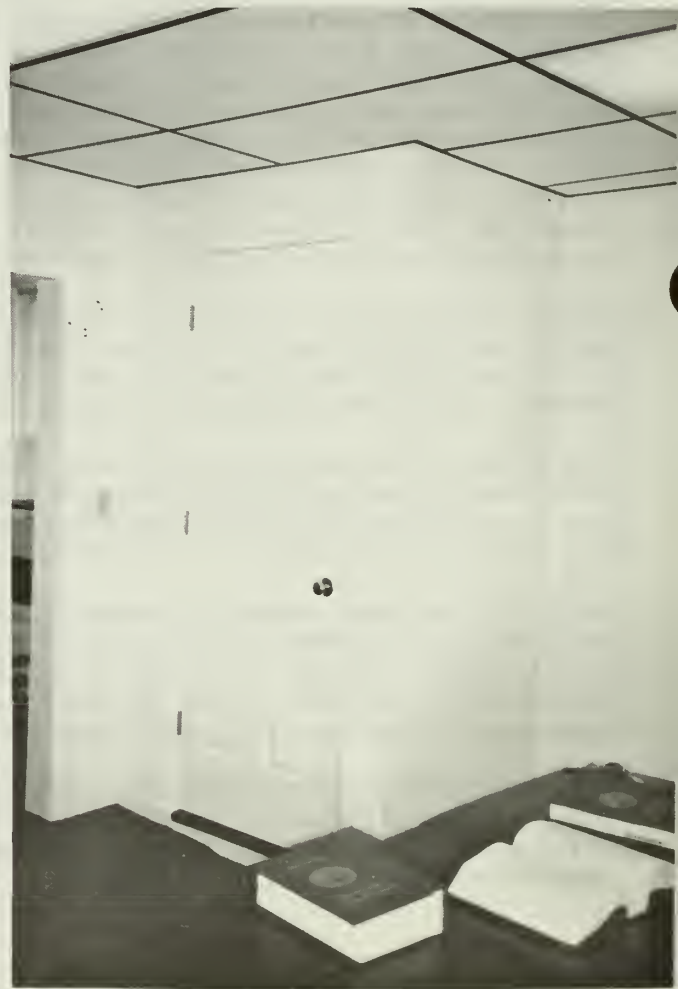
2. This view shows the distracting metal grid and ceiling illumination of the new dropped ceiling.

The project did not retain the architectural character and therefore failed to meet the Standards for Rehabilitation. In this particular case, there was no permanent damage to the historic materials, so the rehabilitation could potentially meet the Standards if the owner were to install a plasterboard ceiling more consistent with the original room proportions, preferably at the minimum required clearance for the HVAC system. One method to better integrate HVAC systems is the use of wall and ceiling chases. Failure to minimize the impact of the HVAC system and dropped ceiling may violate Standard 2.
